# Manhole Inspection Summary

Manhole # S09UU\_001MH

**Location** Address: **LIBERTY HEIGHTS AVE**

Cross Street: **HILTON ST**

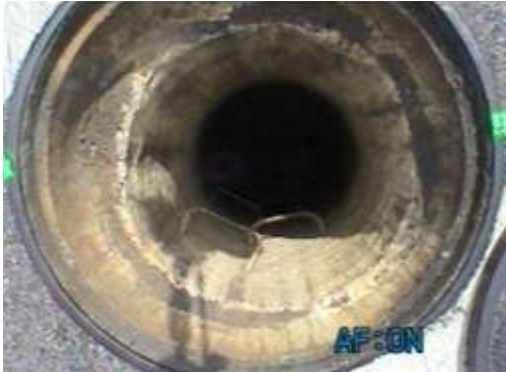
Defect 2

Offset: **4** (in.)

FRAME OFFSET

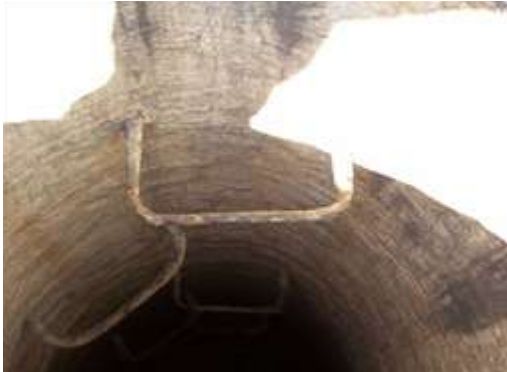
Defect 1

Count: **14** Missing: **0** ☒ **Corroded**

CORRODED STEPS

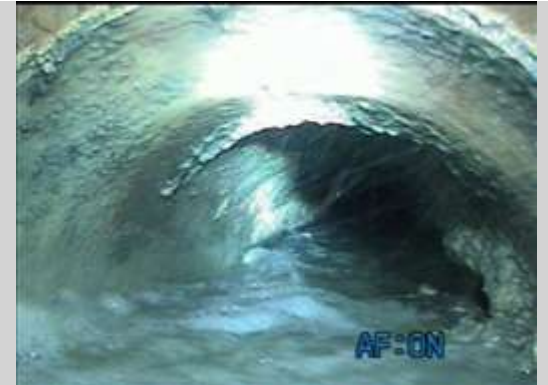
12 O'Clock Outflow

15 in. Circular Gravity Sewer  
Pipe Out @ 12 O'Clock

Pipe Height: (in.) Direct  
Pipe Material: **Unknown** ☐ Pipe Lined  
Invert Depth: **20.41** (ft.) Flow Characteristics: **Turbulent**  
Deposits: ☒ None ☐ Mud ☐ Sludge ☐ Debris ☐ Grease  
Silt Depth: (in.) Deposits Extent:  
Infiltration: **None** Pipe Seal Cond: **Sound**

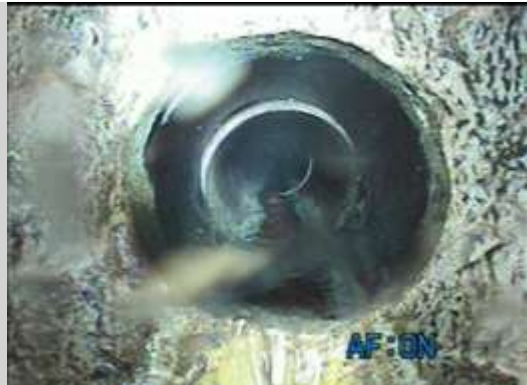
Pipe In @ 4 O'Clock

Pipe Height: (in.) Direct

Pipe Material: **Unknown** ☐ Pipe Lined

Invert Depth: **9.46** (ft.) Flow Characteristics: **Fast**

Infiltration: **None** Pipe Seal Cond: **Unknown**

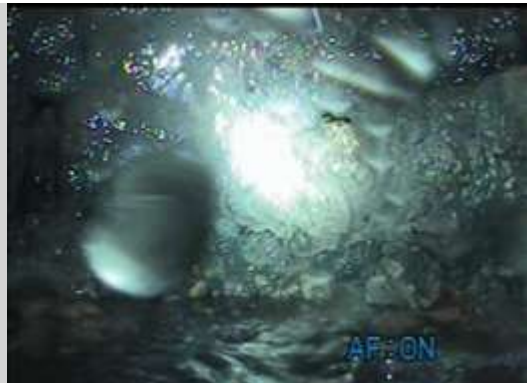
Pipe In @ 6 O'Clock

Pipe Height: (in.) Direct

Pipe Material: **Unknown** ☐ Pipe Lined

Invert Depth: **19.79** (ft.) Flow Characteristics: **None**

Infiltration: **None** Pipe Seal Cond: **Sound**

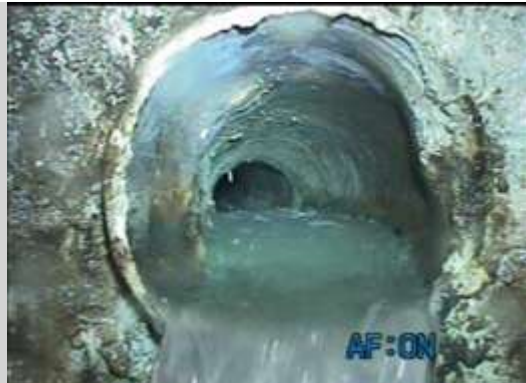
Pipe In @ 9 O'Clock

Pipe Height: (in.) Direct

Pipe Material: **Unknown** ☐ Pipe Lined

Invert Depth: **12.38** (ft.) Flow Characteristics: **Fast**

Infiltration: **None** Pipe Seal Cond: **Sound**

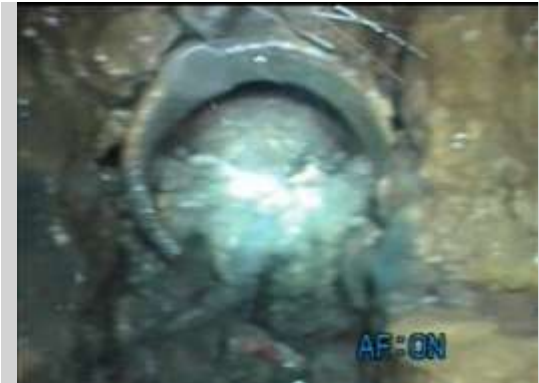
Drop In @ 9 O'Clock

ABANDONED

Drop: **Outside** **Direct**

Inv Depth: **20.12** (ft.)

Drop Condition: **Open**
